**DEPARTMENT OF FISH AND WILDLIFE**

**HABITAT PROGRAM  
TECHNICAL APPLICATIONS DIVISION (TAPPS)**

**LT Murray Wildlife Area Fish Passage Barrier and Diversion Screening  
Scoping and Correction Report**

**August, 2007**

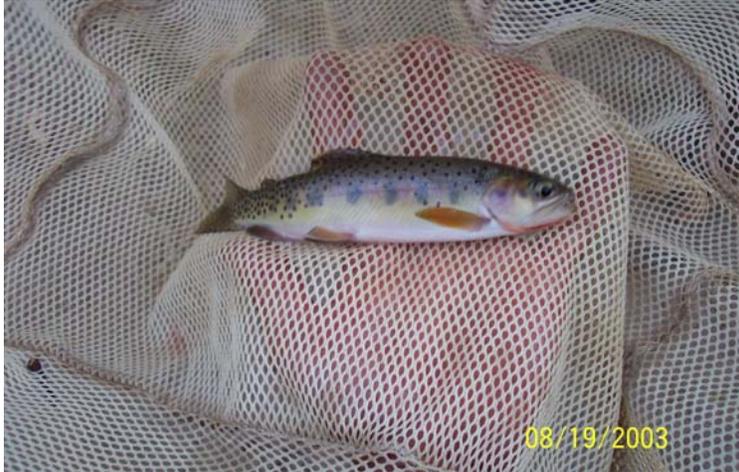
**Photo 1.** Robinson Creek West Slope Cutthroat Trout (*Oncorhynchus clarki lewisi*)

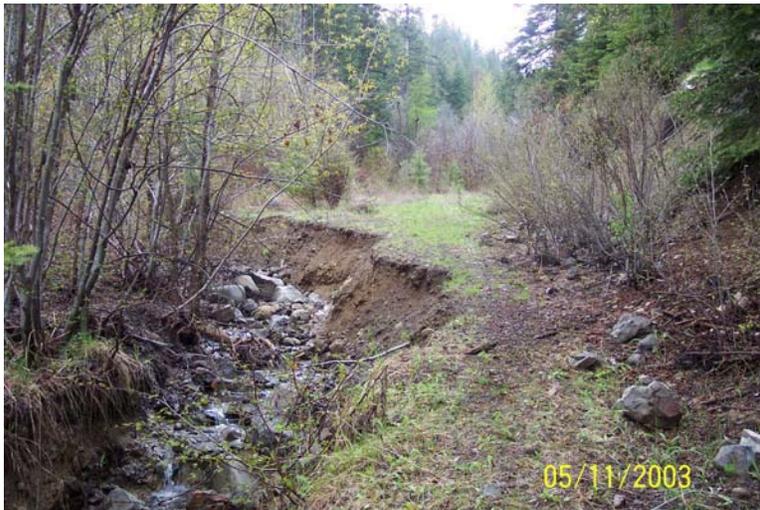
**Photo 2.** Whiskey Creek Road downstream of site 981556, showing severe roadfill erosion which has filled pools with sediment, buried woody debris, and caused channel instability.

On the LTM, many streams are flowing down roadbeds or along roads in ditches. As a result, actively eroding road fills and sedimentation to streams are widespread throughout the wildlife area. Nearly every stream surveyed by TAPPS crews during fish passage barrier inventory surveys was observed to be negatively impacted by past logging, road building, and high grading of large trees out of riparian areas<sup>12</sup>. Notable examples are Whiskey Canyon and Bear Canyon Creeks on the North Fork Manastash watershed, where stream adjacent roads have severely impacted fish habitat (see photo 2).

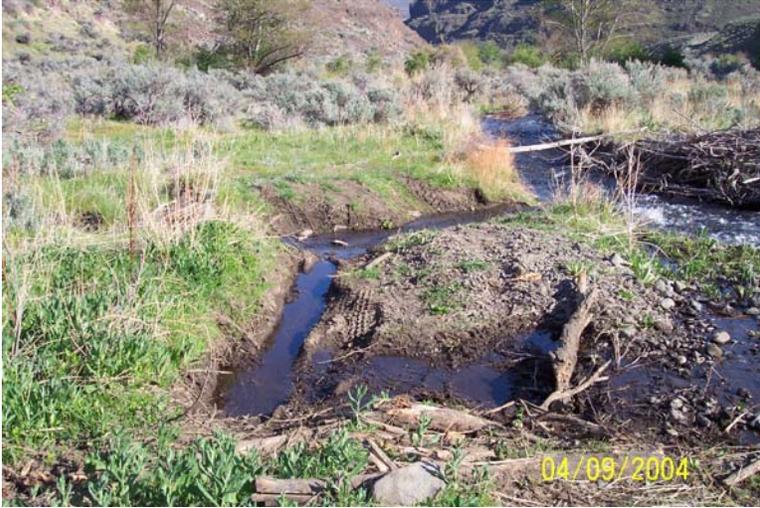
**Photo 3.** Illegal ORV use through Brushy Creek, a lower Quilomene Creek tributary. Federally listed 'Endangered' steelhead were observed spawning in the immediate vicinity of this site in April 2004.

Illegal Off-Road Vehicle (ORV) use on the LT Murray wildlife area has been, and continues to be a significant factor in the deterioration of habitat for both aquatic and terrestrial wildlife. While the 'Green Dot' road management system was instituted in 1990, and ORV use off Green Dot roads is illegal, these rules are often ignored and are difficult to enforce (see Photo 3).

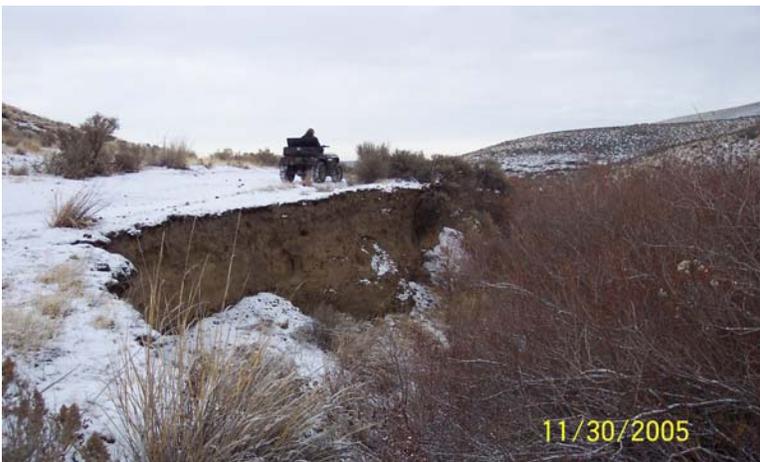
**Photo 4.** Channel incision, eroding roadfill, and recovering riparian vegetation along Whiskey Dick Creek.

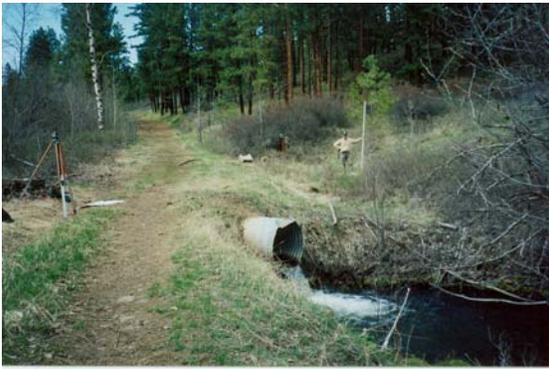
**Photo 5.** Site 981502 before culvert and associated road fill removal.

In the summer of 2003 approximately 8 miles of stream-adjacent road were abandoned in the Robinson Creek watershed. This work included culvert removal, road surface ripping, and excavation of stream-adjacent road fill at appropriate locations. Fish passage barrier culverts were removed at sites 981508, T18R16E-11, 981507, 981506, 981505, 981504, 981502, 981522, and 981521 from mainstem Robinson Creek, Ainsley Creek, and other tributary fish bearing streams on upper Robinson Creek (see Figure 3). In addition, road cross-drain culverts on type 4,5 and 9 streams were removed from abandoned logging roads. The project also included the placement of over 200 pieces of large woody debris at appropriate locations and replanting of all disturbed areas.

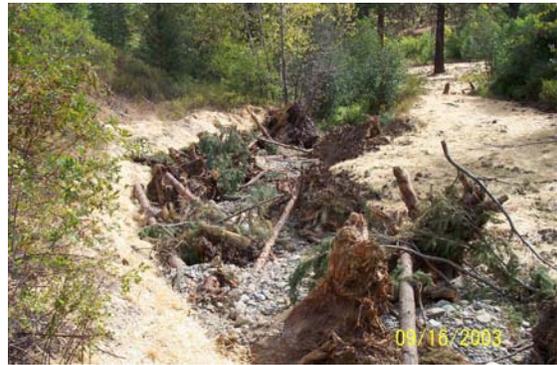
**Photo 6.** Site 981502 following the removal of the barrier culvert and approximately 1000 cubic yards of road fill from the stream channel.

As a result of these culvert removal projects, all man-made fish passage barriers within the Robinson Creek watershed on WDFW-owned lands have been corrected.

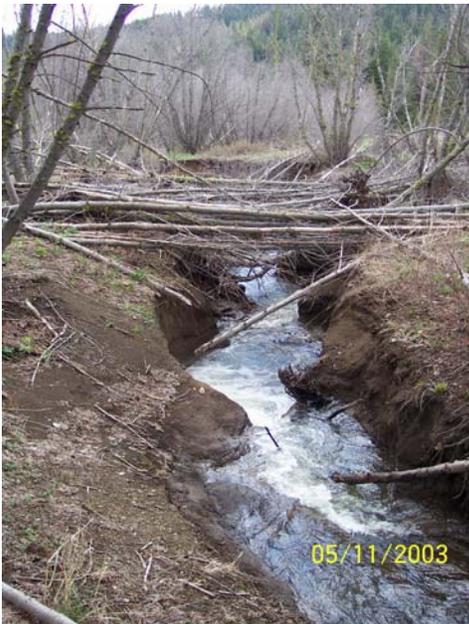
**Photo 7.** Severe channel incision through what appear to be former beaver pond wetlands, RM 12.3, upper NF Manastash Creek.

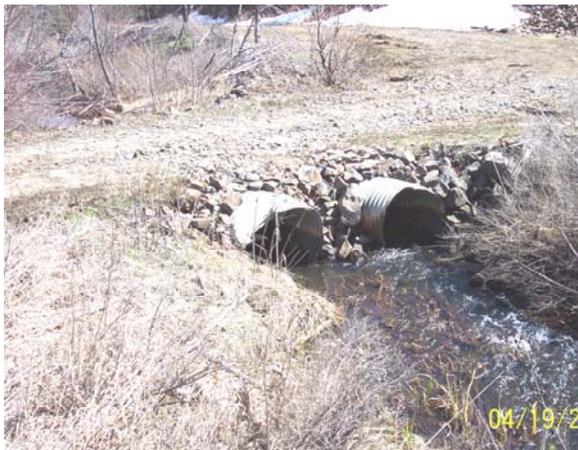
**Photo 8.** Culvert Site 981552 before replacement, NF Manastash Creek, RM 10.39.

Two stream crossings were removed from the mainstem NFM within the LTM. One was an old, non-barrier, failing wooden bridge at RM 5.2, which was removed. The other was a culvert at RM 10.5, under the road, which connects the NFM Road with the Shell Rock Road. This culvert was a barrier culvert, which caused the stream to overtop the road when plugged with debris. In 2005, a twelve-foot diameter bottomless culvert was placed at this site (see Photos 8 and 9).

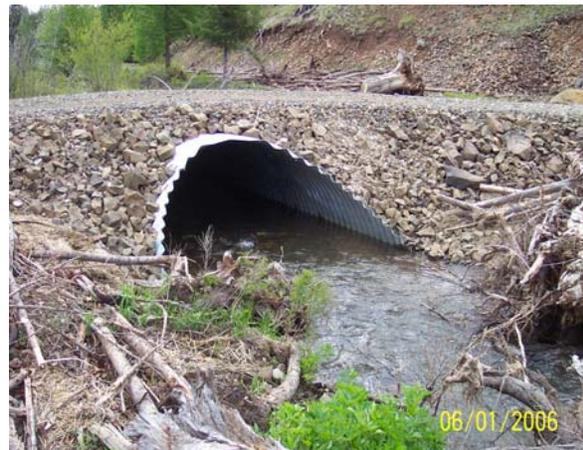
**Photo 9.** Site 981552 after replacement following replacement with a 12 foot wide bottomless culvert

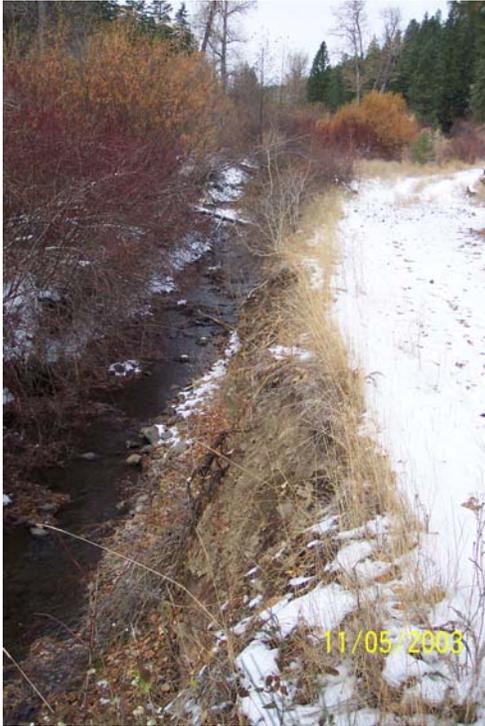
**Photo 10.** Eroding stream-adjacent roadbed along NF Manastash Creek RM 2.2 to 2.4.

In addition to the barrier correction work described above, through the abandonment of the lower NF Manastash road, about 150 conifer trees with rootwads were placed in the NF Manastash and Whiskey Canyon Creek within stream adjacent road-impacted reaches, and approximately 600 cubic yards of actively eroding road fill was pulled away from the NF Manastash mainstem channel (see photos 10 and 11).

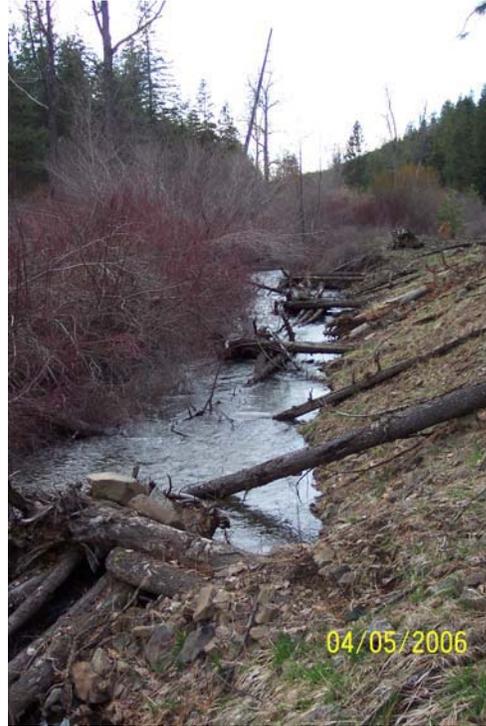
**Photo 11.** Road fill re-sloped and Large woody debris placed, NF Manastash Creek RM 2.2 to 2.4.

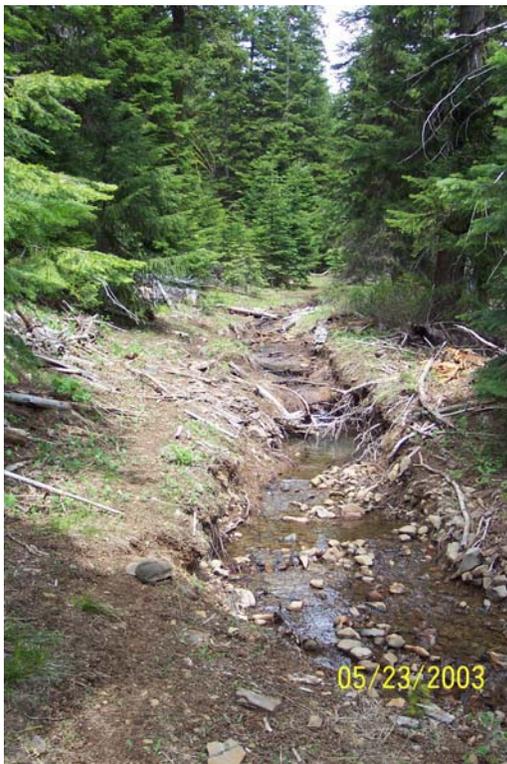
Bear Canyon Creek enters NF Manastash Creek at RM 7.7. The stream is confirmed fish-bearing up to an impassable falls 1,200 meters from the confluence with NF Manastash Creek. Evidence of past logging and roadbuilding are obvious along much of Bear Canyon Creek and the stream flows down an old roadbed at some locations (see Photo 12).

**Photo 12.** Upper Bear Canyon Creek flowing down a logging road, near RM 1.9.

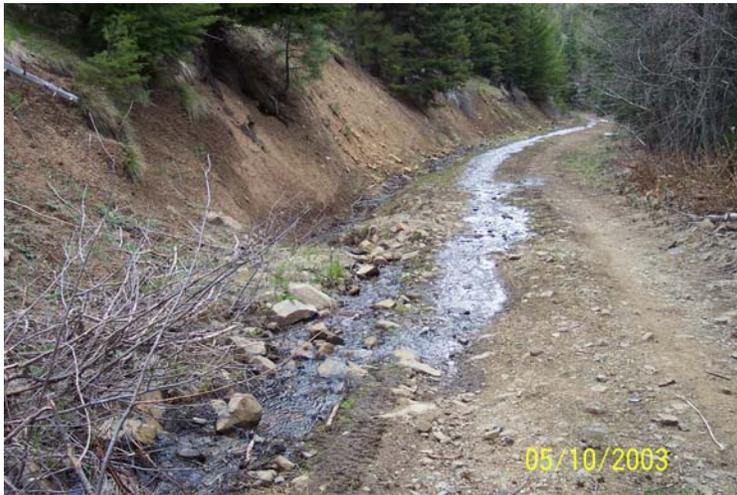
This stream enters the mainstem NFM at RM 10.3, just downstream of site 981552 (see Figure 3). Year-round flows are maintained by springs, which enter the stream approximately 350 m from the confluence with the mainstem NFM. Downstream of these springs, a logging road was constructed within the channel migration zone of the stream. As a result the stream flowed down the road and in ditches along the road. The road was later converted to an active Green Dot road, which served to connect the Shell Rock road to the NF Manastash Road, and has remained open to motor vehicle use. Downstream sedimentation impacts have been severe (see Photo 13).

**Photo 13.** Unnamed tributary to NFM (RM10.3) flowing down roadbed. Culvert 981577 crossed road in near foreground, with streamflow left to right.

During the 2005 construction season, this 2900-foot section of the road was abandoned and 1500 feet of an alternative access along an adjacent ridgeline was constructed. As part of the abandonment, the barrier culvert at site 981577 was removed and the barrier culvert at site 981580 was replaced with a fish-passable culvert. Completion of this project has eliminated a significant source of sedimentation on the lower section of this stream and in the NFM mainstem. All human-made fish passage barriers have been removed from the stream.

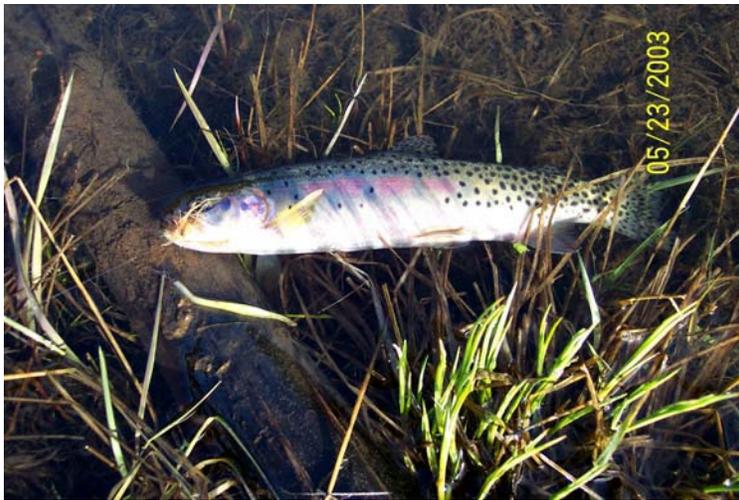
**Photo 14.** Murray Creek westslope cutthroat trout (*Oncorhynchus clarki lewisi*)

Murray Creek enters the NFM mainstem at RM 10.8. The Murray Creek watershed was heavily logged prior to WDFW ownership. As a result, the character of the surrounding landscape has changed from heavily forested with mature conifer to open grassland and scattered patches of immature trees<sup>18</sup>. Large conifer stumps along upper Murray Creek attest to the historic nature of the riparian zone along the stream. Young trees have replaced the logged out forest and dense stands of deciduous trees have grown up in the riparian zone of the stream. Flows in Murray Creek are perennial and are adequate to support fish life. Westslope cutthroat are present in the stream (see Photo 14).

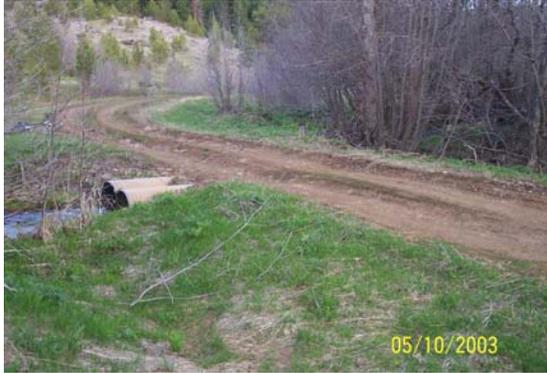
**Photo 15.** Site 981571 before replacement.

Three fish passage barrier features, sites 981570, 981571 and T18 R16E-5 were removed during 2005 and 2006. The culvert crossings at sites 981571 and T18 R16E-5 are located on an active Green Dot road, which remains open to motorized vehicle use. During the 2005 construction season, the culvert at site 981571 was replaced with an 8-foot wide, bottomless culvert (see Photos 15 and 16).

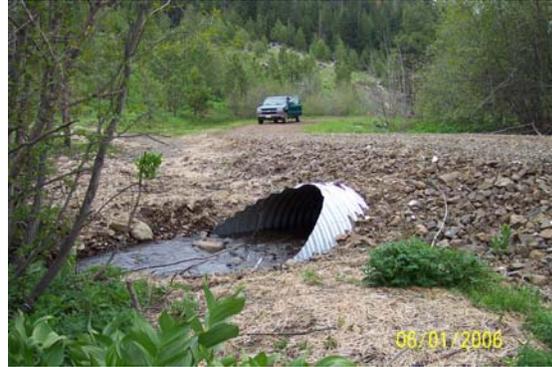
**Photo 16.** Site 981571 after culvert replacement.

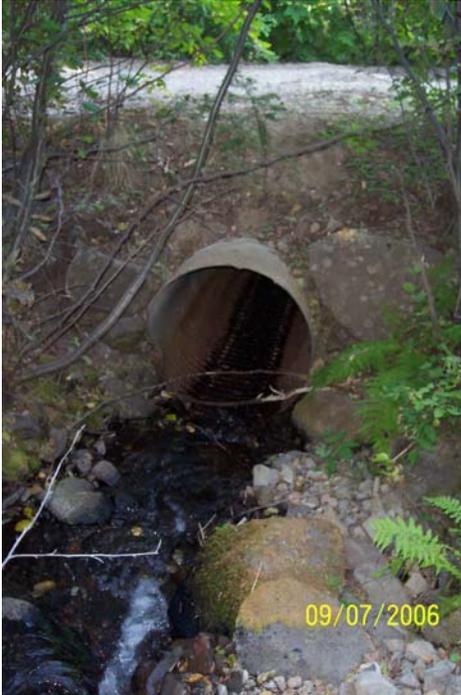
**Photo 17.** Shadow Creek site 981519 before culvert replacement.

During 2006, culverts at sites 981518 and 981519 (see Photos 17 and 18), and an abandoned concrete dam at site 981650 were removed from Shadow Creek. Like Robinson Creek, Westslope cutthroat trout (*Oncorhynchus clarki lewis*) were found to be numerous in Shadow Creek during fish relocation efforts at barrier removal sites.

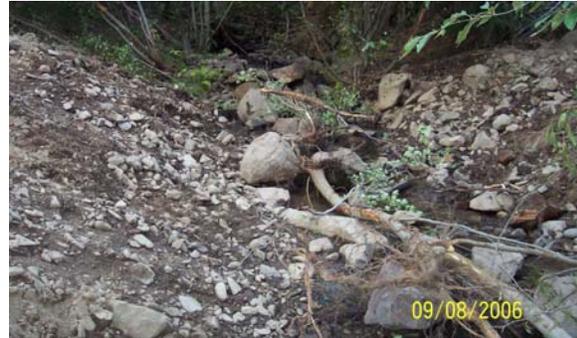
**Photo 18.** Shadow Creek site 981519 following culvert removal.

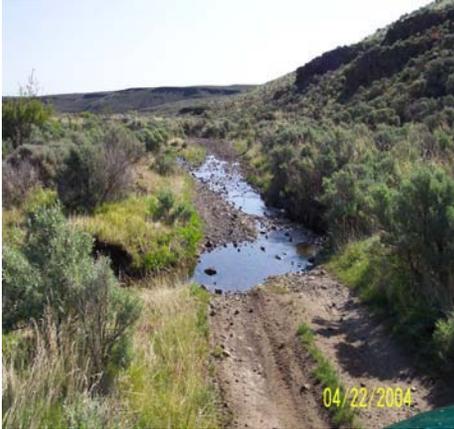
watersheds have a disproportionate impact on streams because the majority of the roads were built along, and even through streams and riparian areas. Some ford crossings on lower Whiskey Dick Creek are barriers to fish passage at certain flows, and their use has had a detrimental effect on riparian vegetation, bank stability, and normal sedimentation regimes (see Photos 19, 20, 21).

**Photo 19:** Whiskey Dick Creek ford crossing.

In the future, eight ford crossings, sites 981630, 981631, 981629, 981627, 981626, 981625, 981624 and 981623 will be abandoned through the permanent closure of approximately six miles of stream adjacent road along Whiskey Dick Creek. The ford crossing at site 981619 will remain open to motor vehicle use, but will be upgraded to minimize potential impacts to fish.

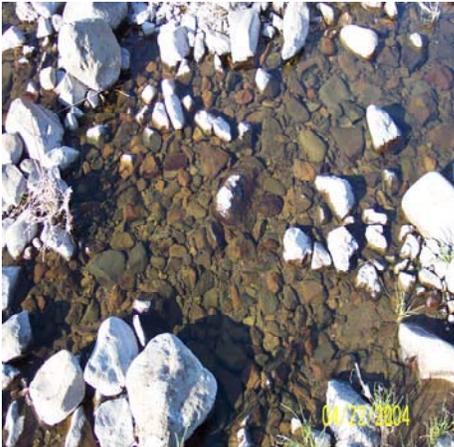
**Photo 20:** Streambed just upstream of ford crossing shown in Photo 19.

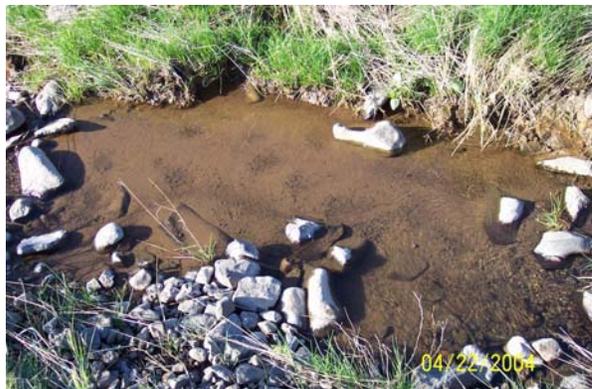
**Photo 21:** Streambed just downstream of ford crossing shown in Photo 19.
